ACOUSTIC SENSOR  
 ENGINEERING EVALUATION TEST REPORT

Prepared By  
 Lockheed Electronics Company, Inc.  
 Aerospace Systems Division  
 Houston, Texas

JSC-11159

PROJECT SPACE SHUTTLE

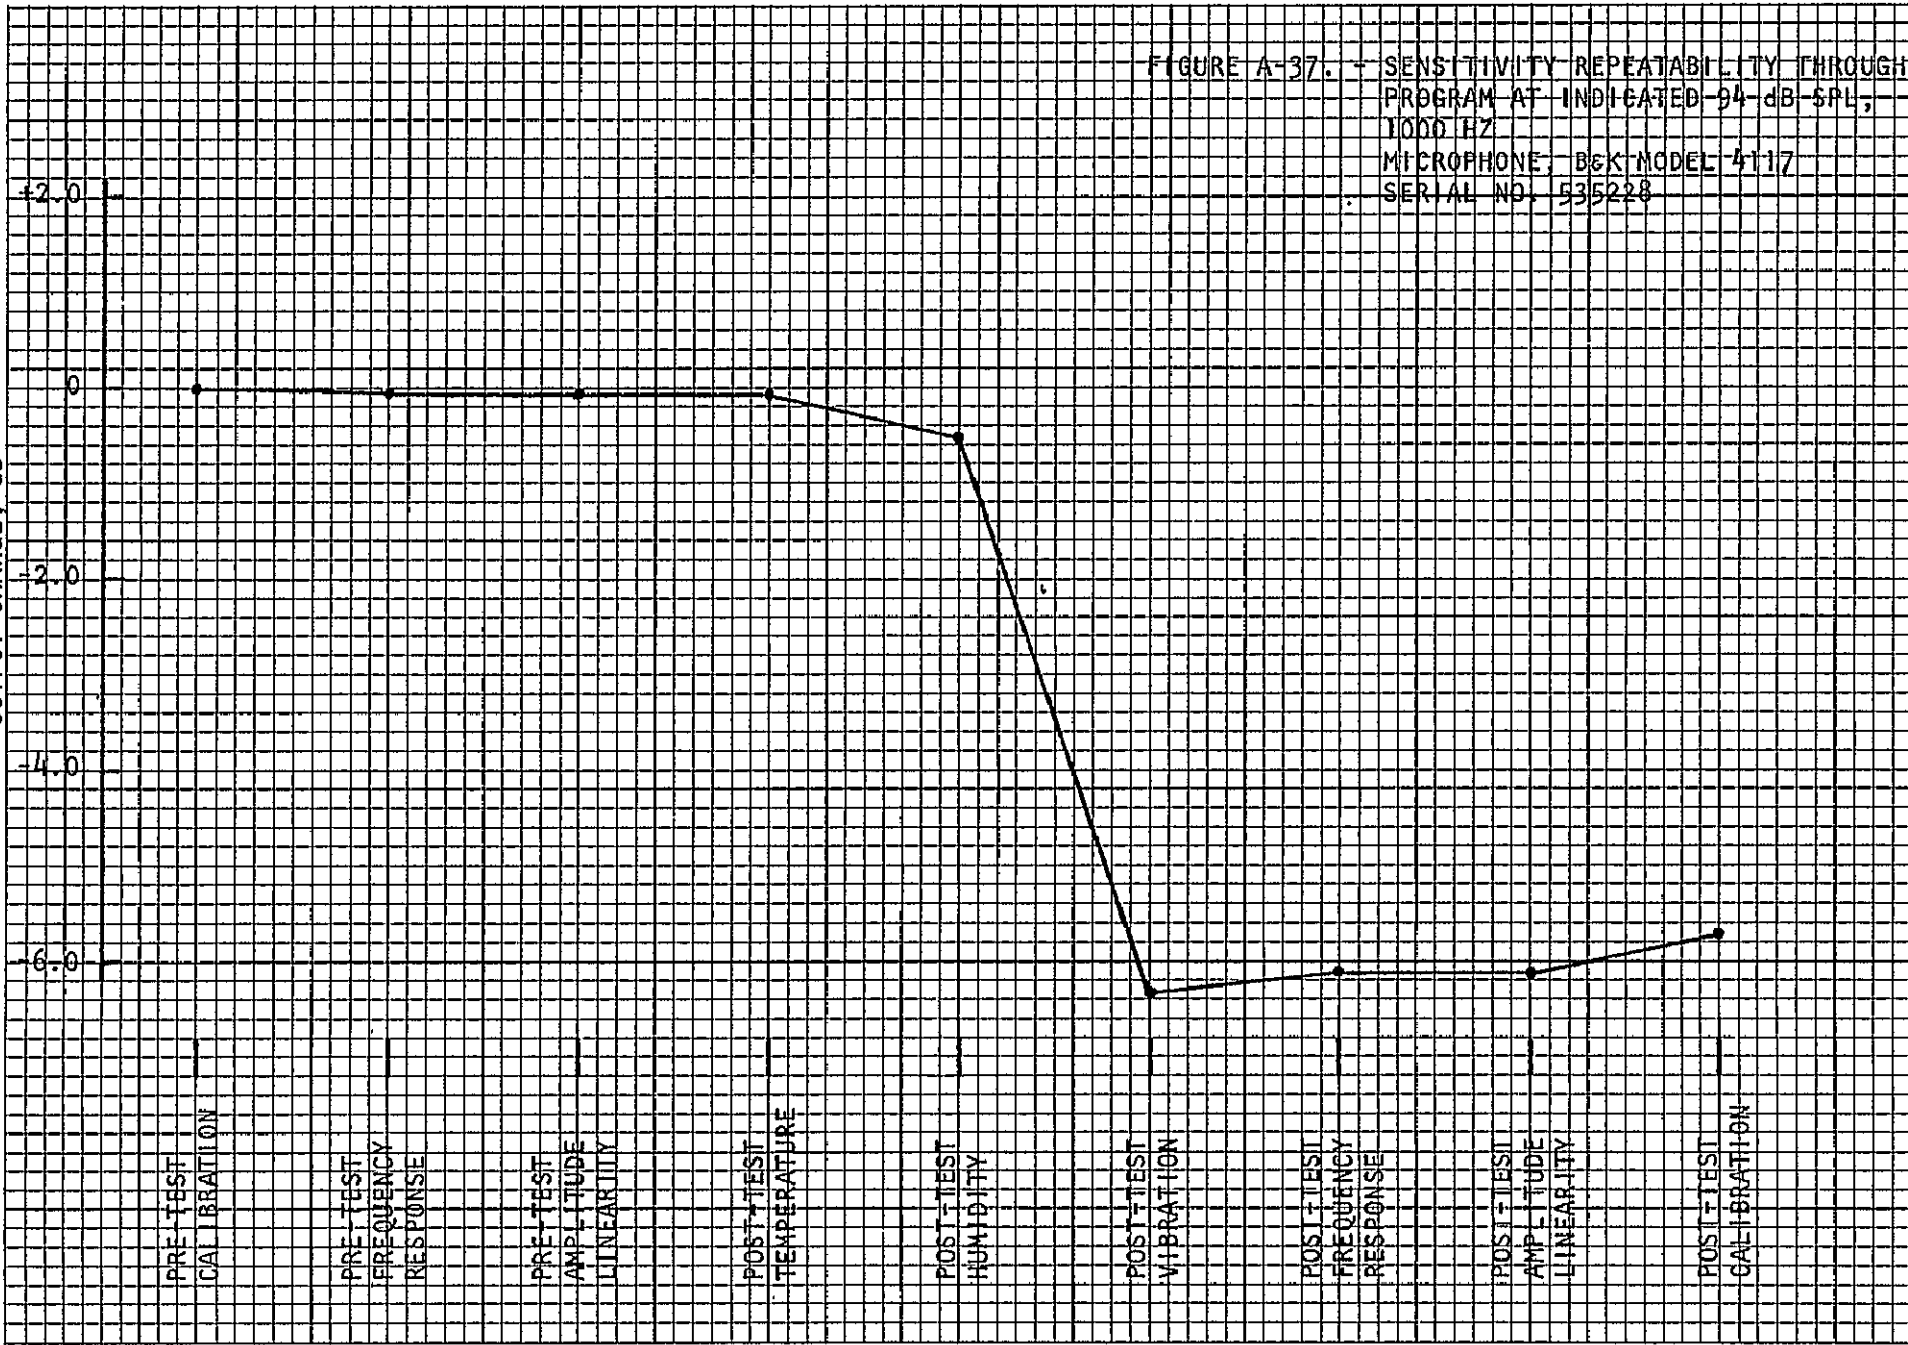
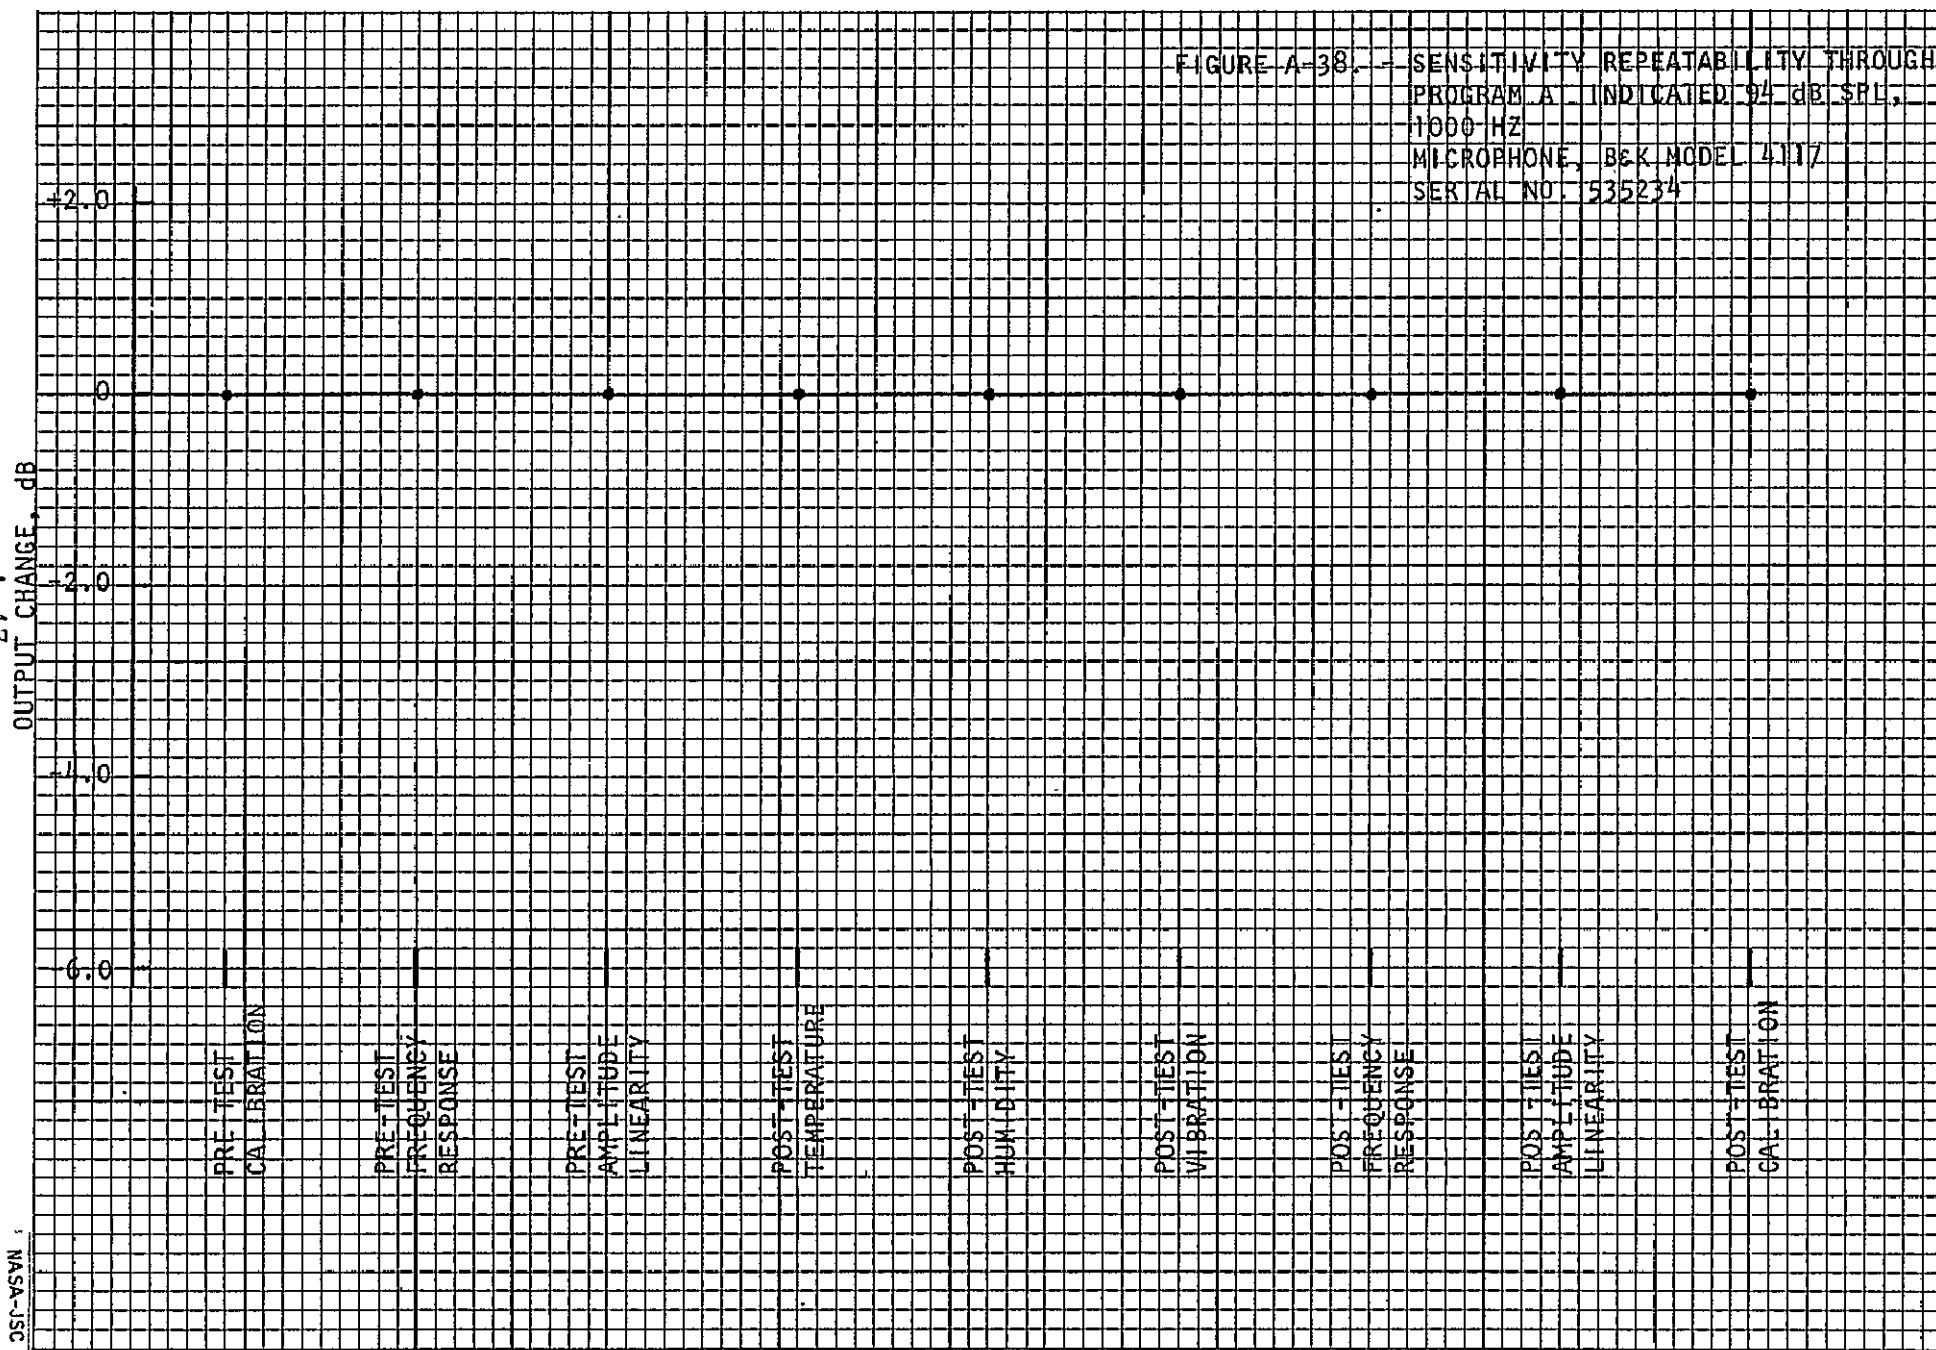
FIGURES A-35 THROUGH A-38

B&K Model 4117 Sensitivity  
Repeatability Data

Both the B&K Model 4161 and Model 4117 capacitive microphones are deemed suitable for use on the Shuttle Orbiter vehicle based upon the results of the tests described herein. The Model 4117 is apparently less precise and much more fragile. One Model 4117 test article, serial number 535219, failed following the humidity test. Another unit, serial number 535228, had a substantially degraded output following random vibration exposure. Otherwise the sensitivity repeatability of all the test articles was within 1 dB of the respective initial value throughout the test program. The repeatability of each of the eight test articles is shown in Figures A-31 through A-38 in the attachment to this report.
